# OPERATION PLUMBBOB

NEVADA TEST SITE  
MAY-OCTOBER 1957

Project 3.5a

ISOLATION OF STRUCTURES FROM GROUND SHOCK

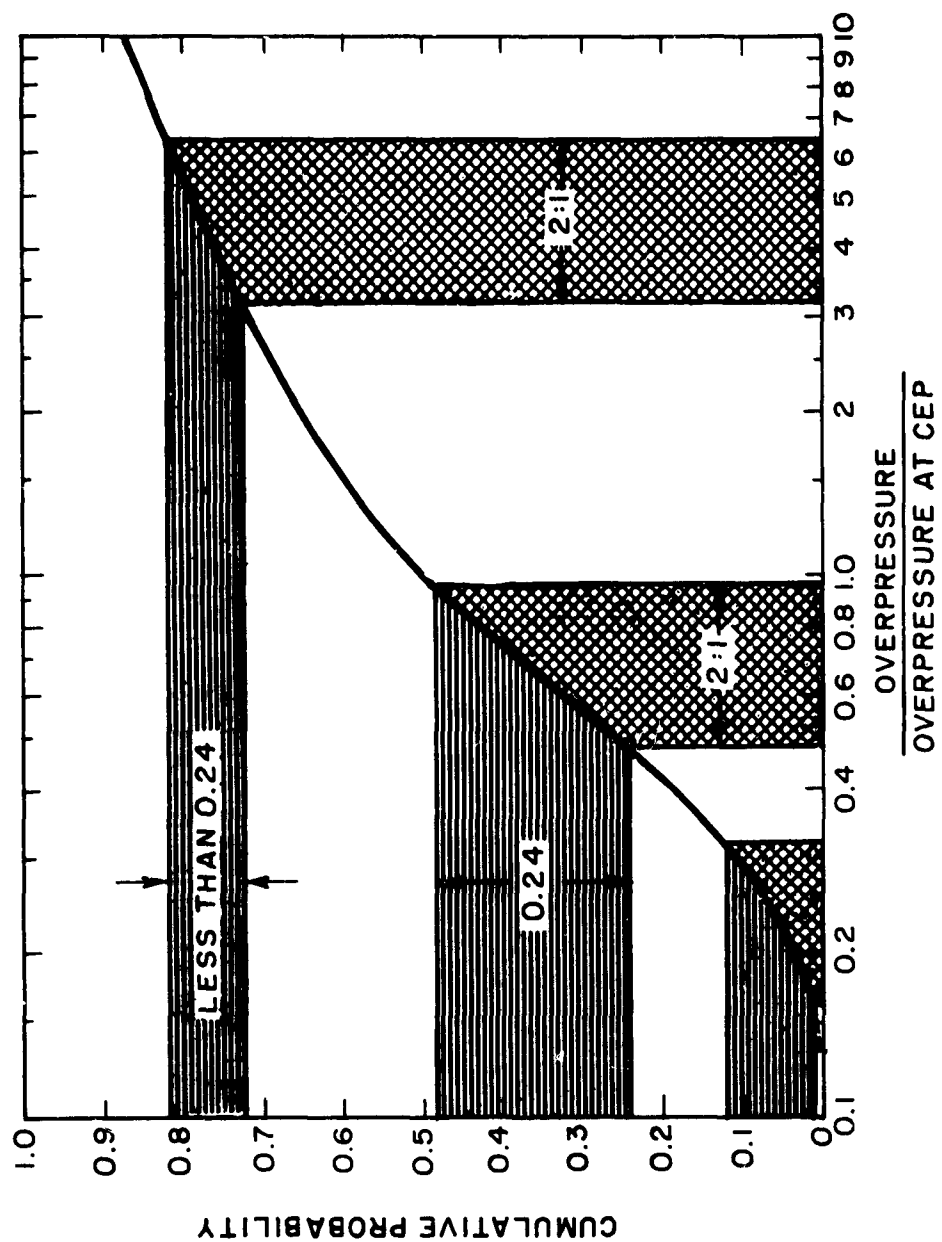
Figure 4.2 Probability versus overpressure.
